# A + ROOFING

**Castro Roofing of Texas passes all tests to reroof the University of Houston Science Center**

**Project name:** University of Houston Science Center  
**Project location:** Houston  
**Project duration:** January 2010-March 2010  
**Roof system type:** TPO  
**Roofing contractor:** Castro Roofing of Texas LP, Dallas  
**Product manufacturers:** GAF, Wayne, N.J.; USG Corp., Chicago

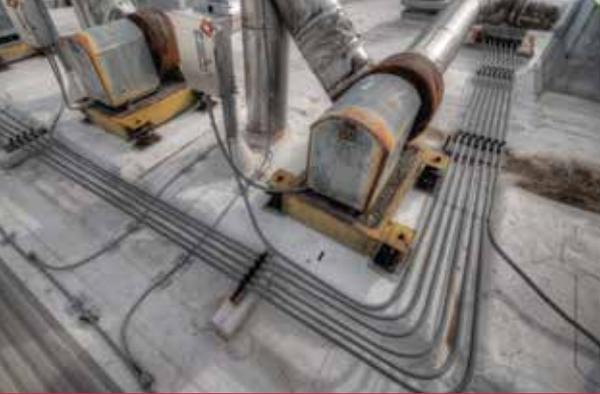
Castro Roofing used mechanized equipment to cut the existing membrane into manageable sections. Workers then removed the debris to a crane staging area where the material was hoisted over a 16-foot-high perimeter screen and into trash bins. This required careful maneuvering around miles of piping and more than 180 roof penetrations without interrupting the building's occupants and research laboratory. Multiple roof levels further complicated the process.

Following tear-off, a vented base sheet then was mechanically fastened to the lightweight concrete deck, followed by 3-inch-thick EnergyGuard™ Tapered PolyIso Foam Roof Insulation. Some rooftop curbs were so close, Castro Roofing closed the gaps with insulation to make multiple curbs into one.

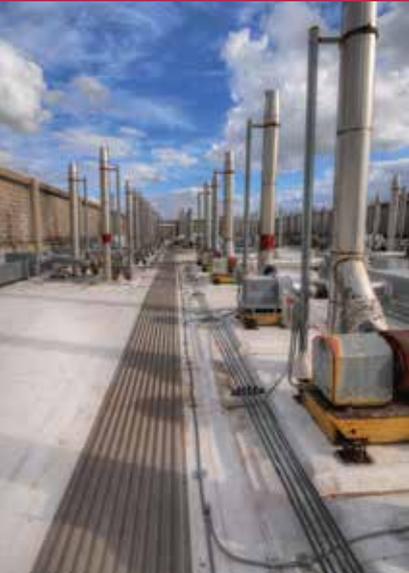
Top to bottom: 14,400 linear feet of electrical conduit was raised 1 inch before removing the old roof system and repositioned with new supports following the new roof system installation; 2,400 square feet of lightning protection was removed and reinstalled along with a new walkway for safety.

New sheet-metal flashings and wood blocking also were installed, followed by reinstallation and repositioning of the 2,400 square feet of code-required lightning protection. A new walkway was added for safety.

In addition, Castro Roofing had to raise 14,400 linear feet of electrical conduit 1 inch before removing the old roof system. The new roof system then was carefully installed underneath the conduit. Following installation, the conduit then was repositioned with new conduit supports and protection pads—all tasks were performed without power disconnection.
